Belgium, Herselt, August 2nd, 2005

Short Tour in a Low-energy / Renewable-energy House

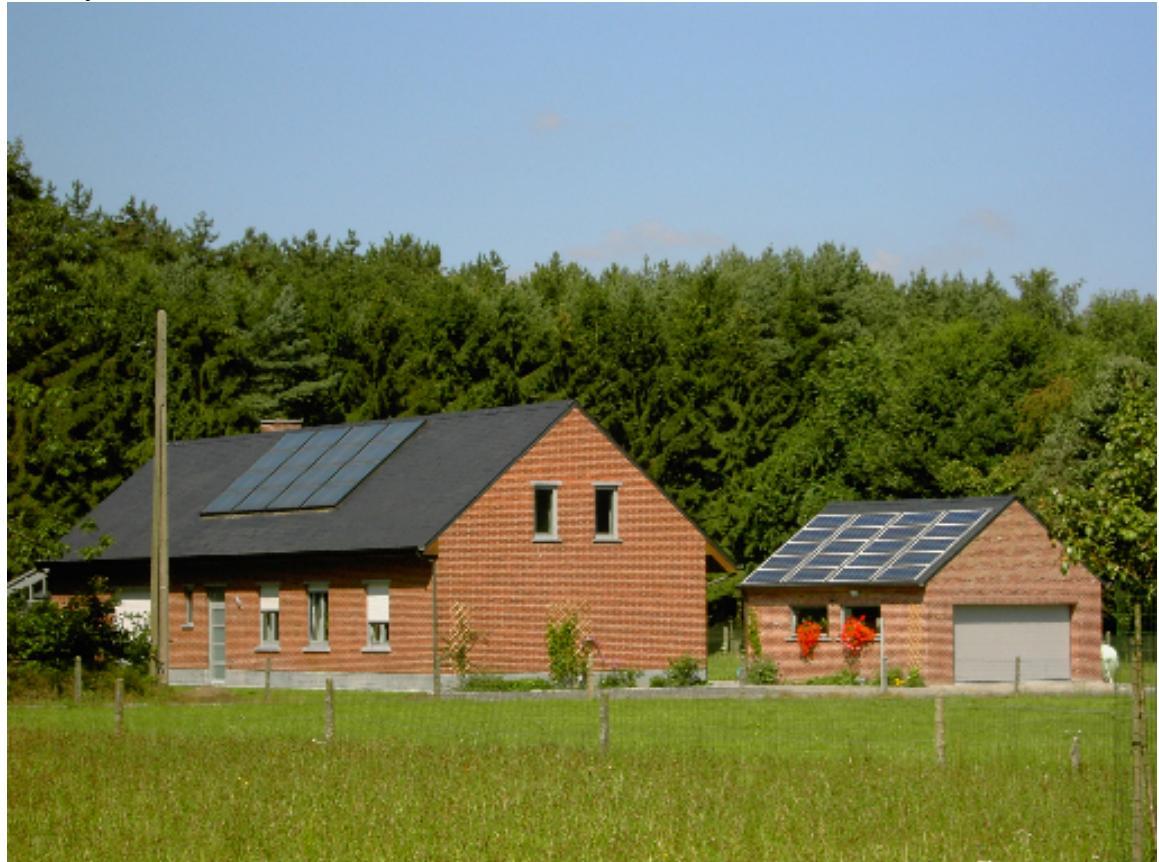
The house and the garage from the street, as any of the many hikers and bikers passing by our house see it. There are hundreds of such 'long' houses in the countryside of the region we live now (called the "Kempen"). Our house measures ca. 20 by 7 meters at the outside; the garage ca.7 x7 m. We bought the house in 1995 because the long sides of the constructions face the south. We had to conserve the basic construction, so the length, height, slope of the roofs, and even position and size of doors and windows was not or only slightly altered at the house. For the garage more degrees of freedom were allowed.

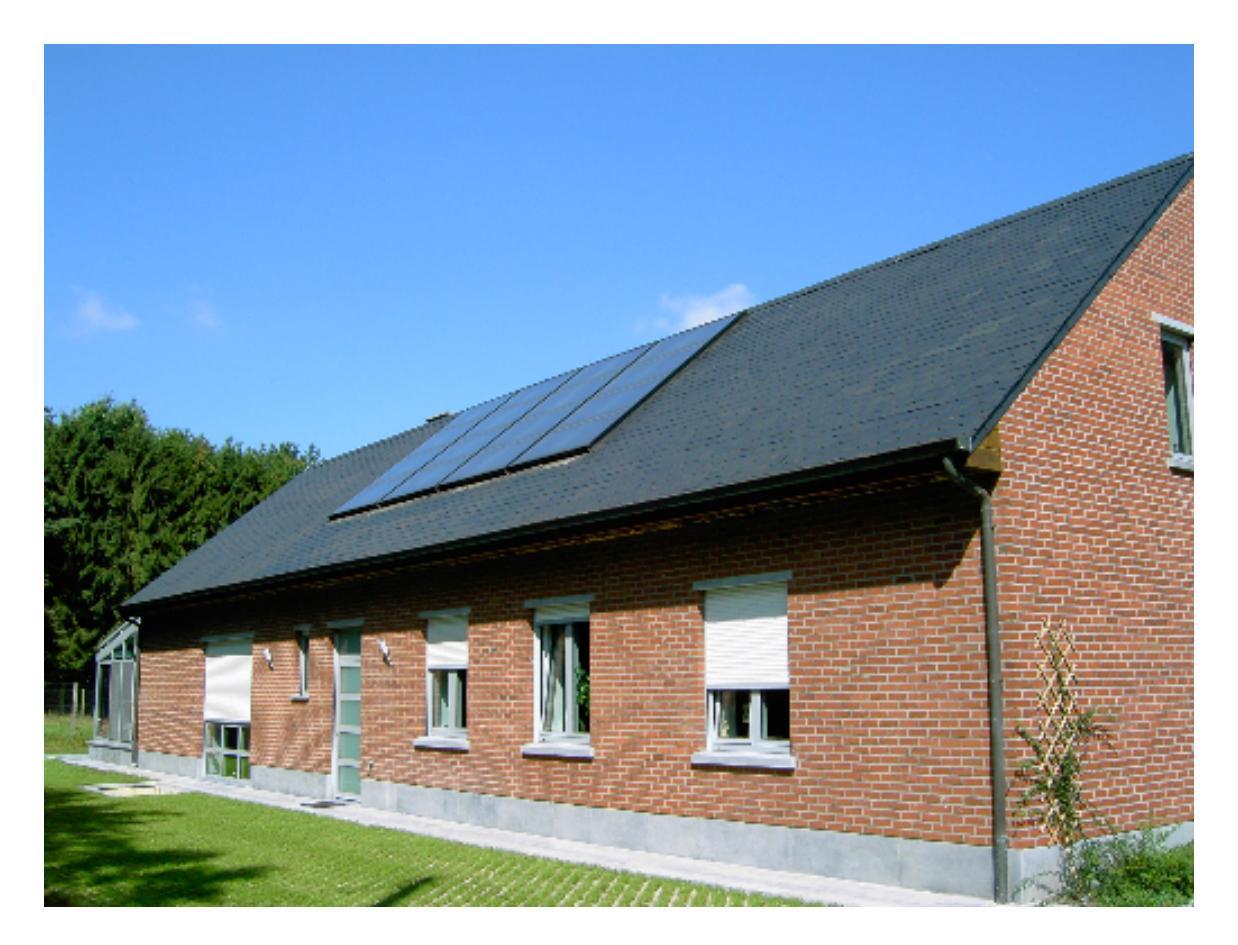
Approaching the house from the street side, the front of the house fully directed southwards. On this picture and the next ones you see the roof that shadows a little the south wall, but for keeping heat out the window blades are more important. Thanks to the insulation and the shadowing, the inside temperature does not pass 25°C when outside temperatures surpass 35°C. Some evening-night-early morning cooling by opening some doors or windows also helps to bring the morning temperature in hot summer days down to around 22°C. Artificial cooling is not required to obtain a high degree of comfort.

The house has a 22 m² hot water solar panel for hot water supply and for heating. The house is heated with a LPG condensing boiler or with the solar boiler, the latter always having priority. Therefore the water circuit is driven at an outgoing temperature of maximum 35° C, mostly 30° C. The ground level of the house has a floor heating circuit and the upper level a few well sized radiators. Due to the thermal integrity and the high stone mass of the house, the thermal inertia is important. When it freezes in winter (up to - 5° C/-10°C is happening but colder is rather exceptional around here), the temperature loss in the house without heating during the night (11 pm till 7 am) is about 3°C.

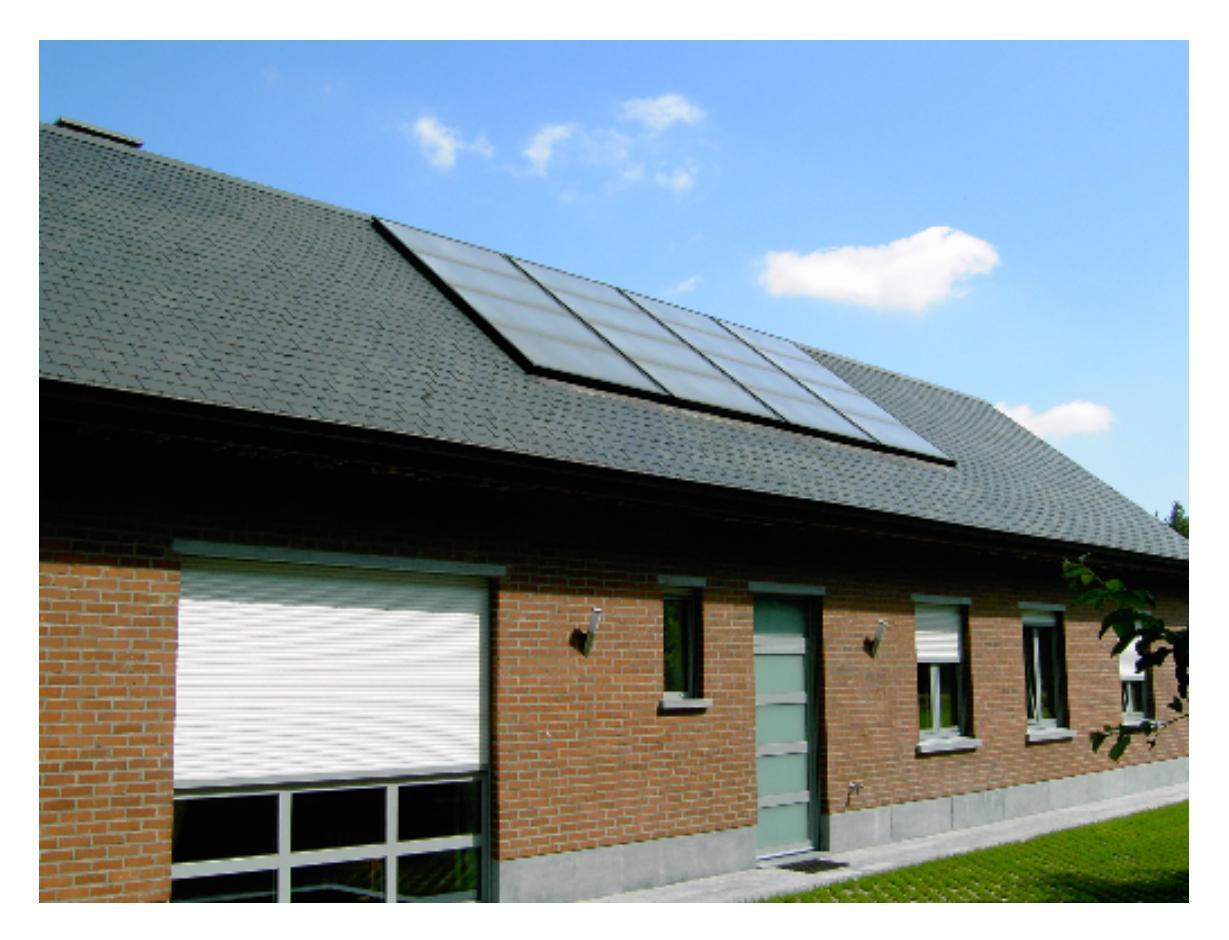
We continue our walk around the house at the south side, and you see the blade of the large window of the living room half closed. Also observe that we did a good investment in a future power plant site, because the south side of the roof still leaves about 70 m² over for more solar panels to come (when the technology has improved and the price of fossil fuels gone up we can install more than 5 kW PV extra).

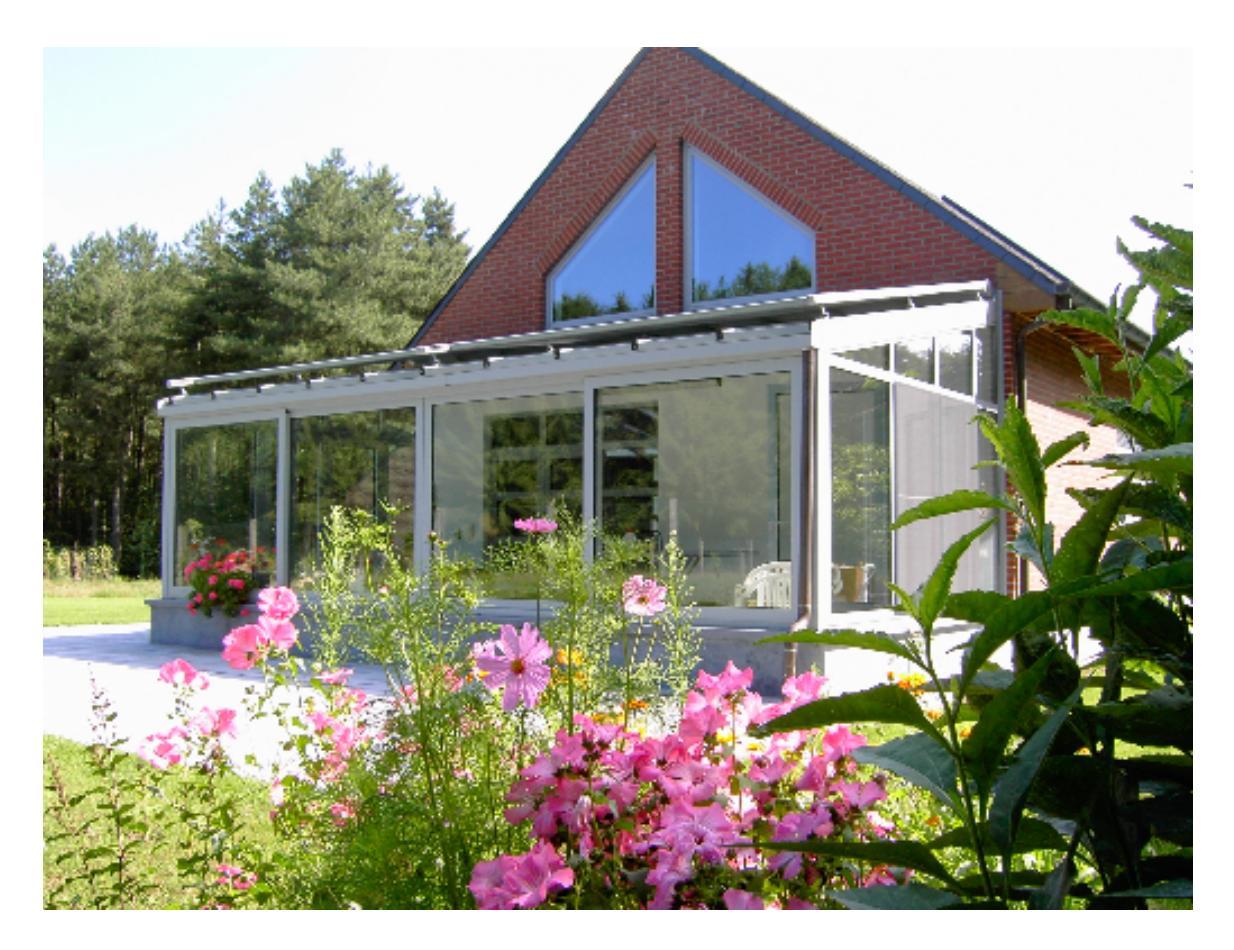
This is the West side with a greenhouse space (we call it veranda). It has a screen on top that we open or close depending on the amount of sun and light we want to allow. It is a perfect place in Spring and Autumn and in cold summer days, but in winter we use it as a fridge, although we can heat it (e.g. for special days such as family meetings on Christmas). The veranda extends the living space most of the year with about 25m².

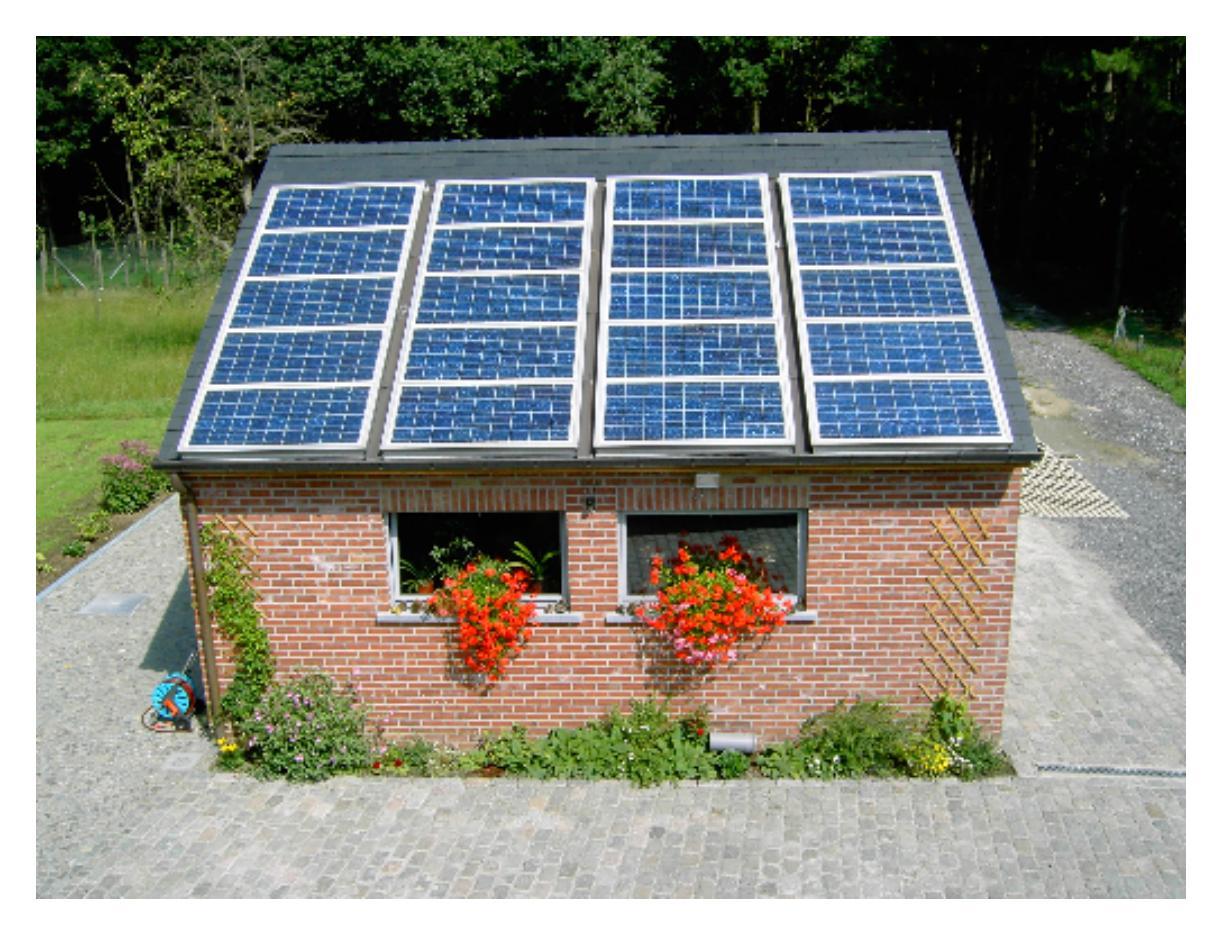
The full panel seen from a window at the first floor of the house. What you can't see is that inside the garage we have a 2.5 m deep basement (it was not possible to construct this in the house itself because of stability problems). In the basement we have two large freezers and several cases of the best Belgian beers (Orval, Chimay, Rochefort, Westmalle, Geuze, Duvel, etc.). We reach a high degree of autonomy in food supply because my wife loves gardening, and some meat is bought from local people that hold rabbits, sheep, deer, ducks, chickens, etc..

[Note added in April, 2009: More than 4 year experience later, we have experienced that we can keep our annual electricity consumption down to about 3000 kWh. The production by the panels is almost 876 kWh/kW-peak installed, i.e. an utilization factor of the nominal peak capacity of 10 per cent. For our 2.4 kW rack our production equals 2100 kWh per year. Given a subsidy of 150 euro per MWh solar output, and a price of power of the same height during the last years, we had an overall negative electricity bill of 150 euro per year. The bill of the annual 1000 liter propane gas was about 450 euro. This means that annual expenses for energy use, amounted to about 300 euro net.]

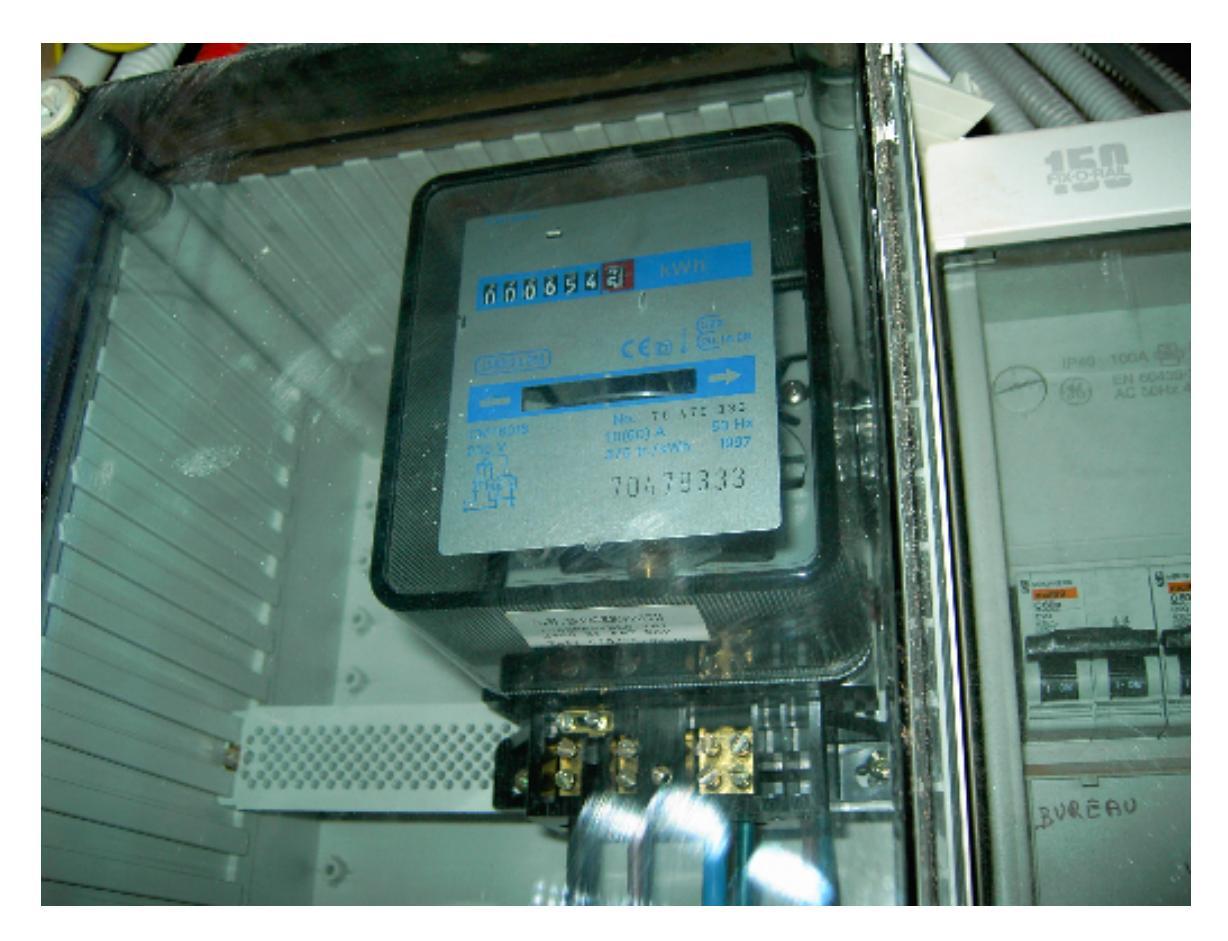
The electricity meter at a low of 654 kWh. In summer it is further coming down, but in winter it will go up. Anyhow over the last billing year June 04- June 05 my consumption was negative (because we came to live in the house with Christmas 2004), so the company has to pay us back ... wait and see how they handle it.

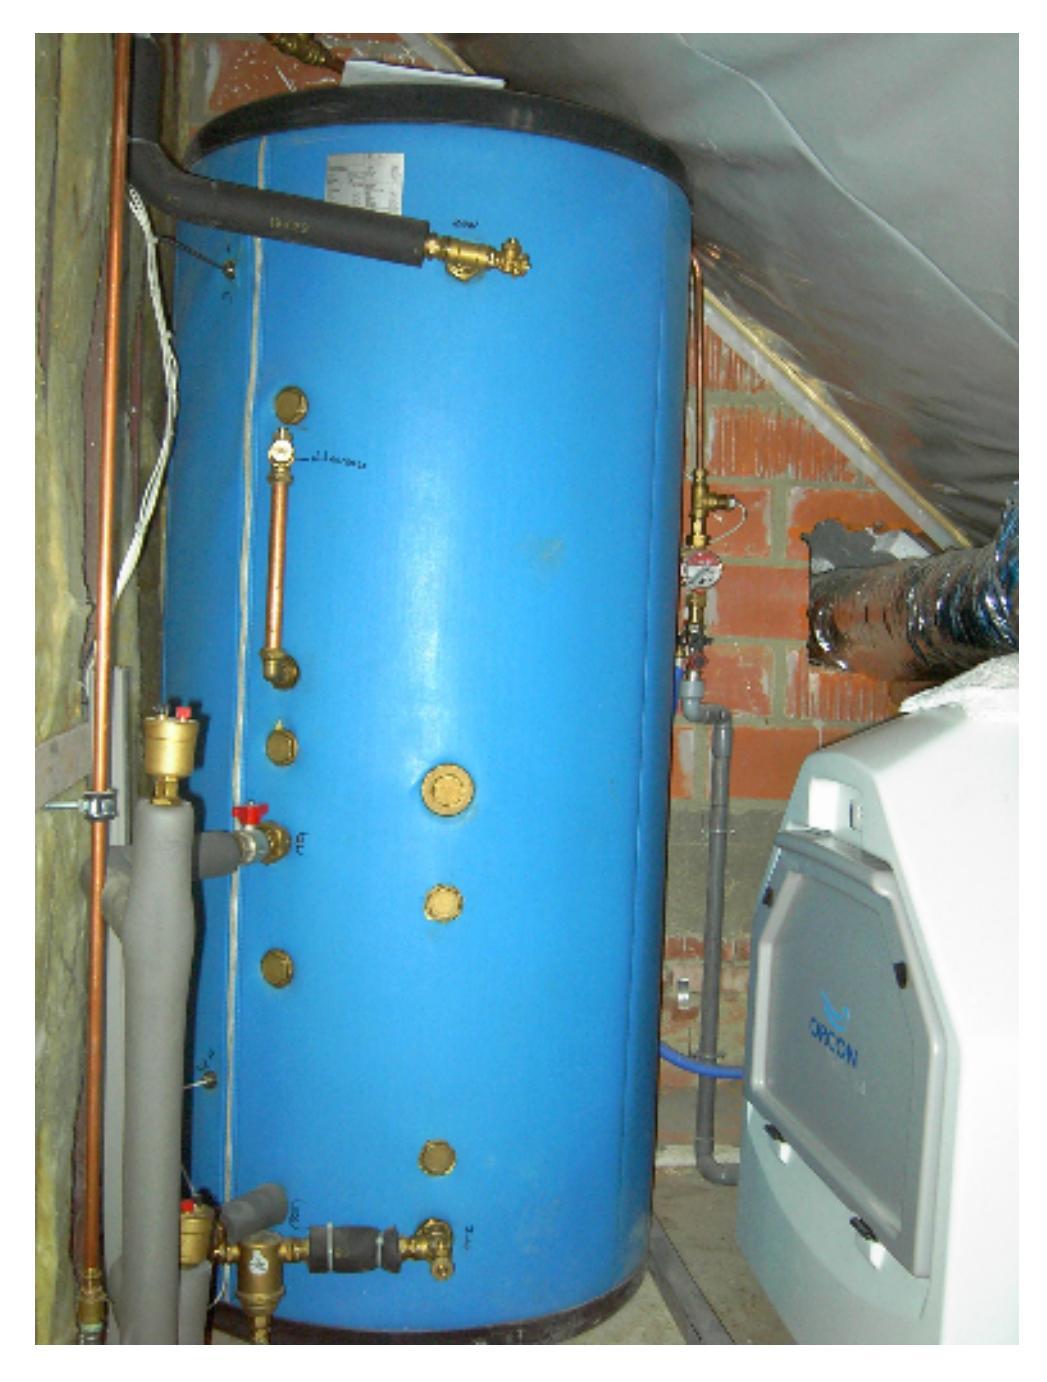
Now we entered the technical spaces of the house. On the upper floor we have a small space that houses the 600 liter solar boiler (blue cylinder) and the heat exchanger and direct current motor of the ventilation unit (white box to the right side). The solar boiler contains a sanitary water exchanger and the remainder is for space heating. The heat exchanger of the ventilation unit extracts 96% of the heat in the outgoing air flow; in summer there is a by-pass that starts automatically to avoid the extracted heat to be re-injected.

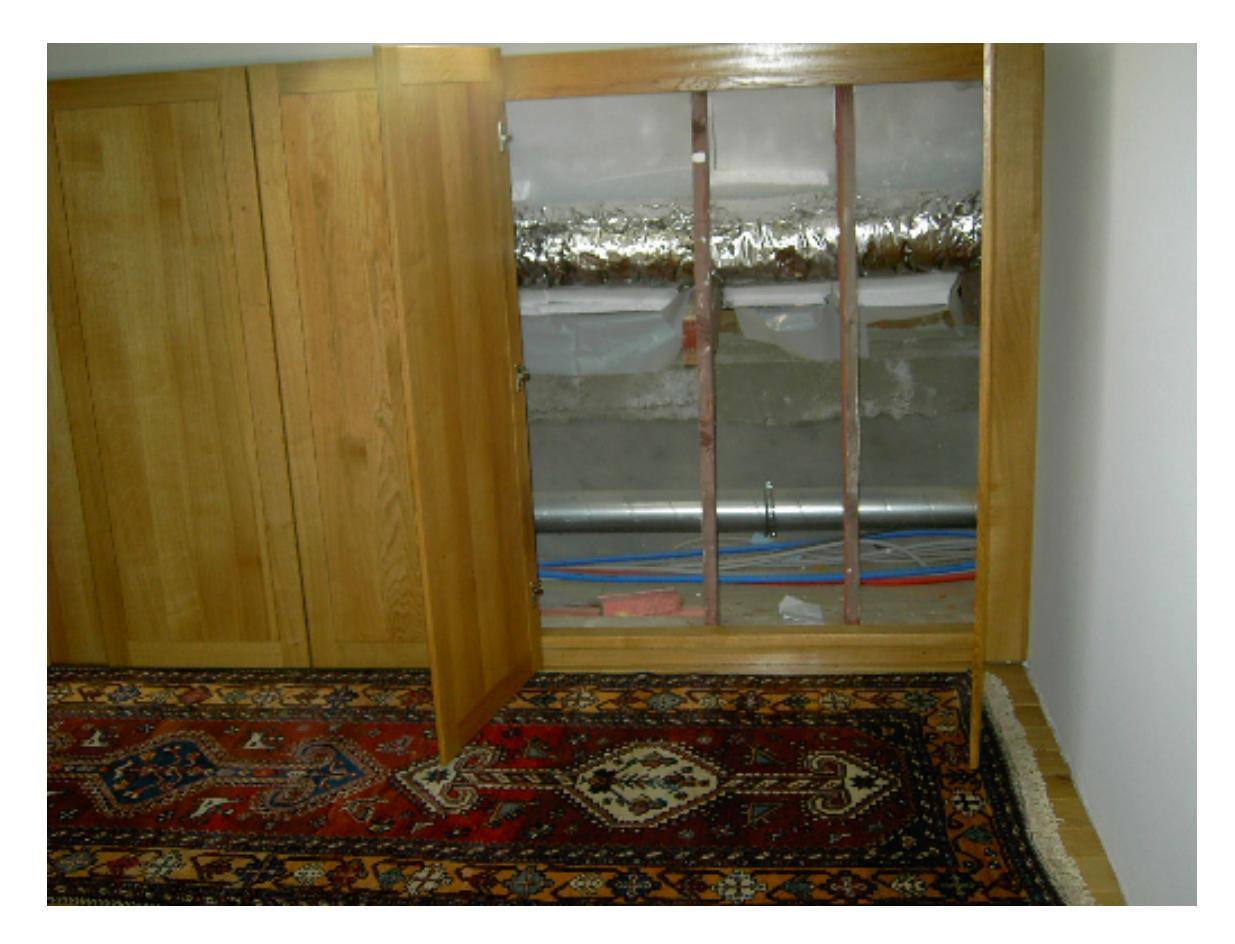
For balanced ventilation you need ducts, and we had to accommodate them in the house. Because the house is an old land house with a low upper floor at the long sides (south and north of the house), we organized two long box-rooms along the sides. We can open the boxes everywhere, but you see that some space is taken by the ducts, electricity cabling and water pipes. Here you see an insulated duct (for fresh inlet air towards the exchanger) and another one to distribute or extract air from the rooms. The natural light from an attic window falls on one of our Bakhtiari (nomad tribe of Iran) carpets.

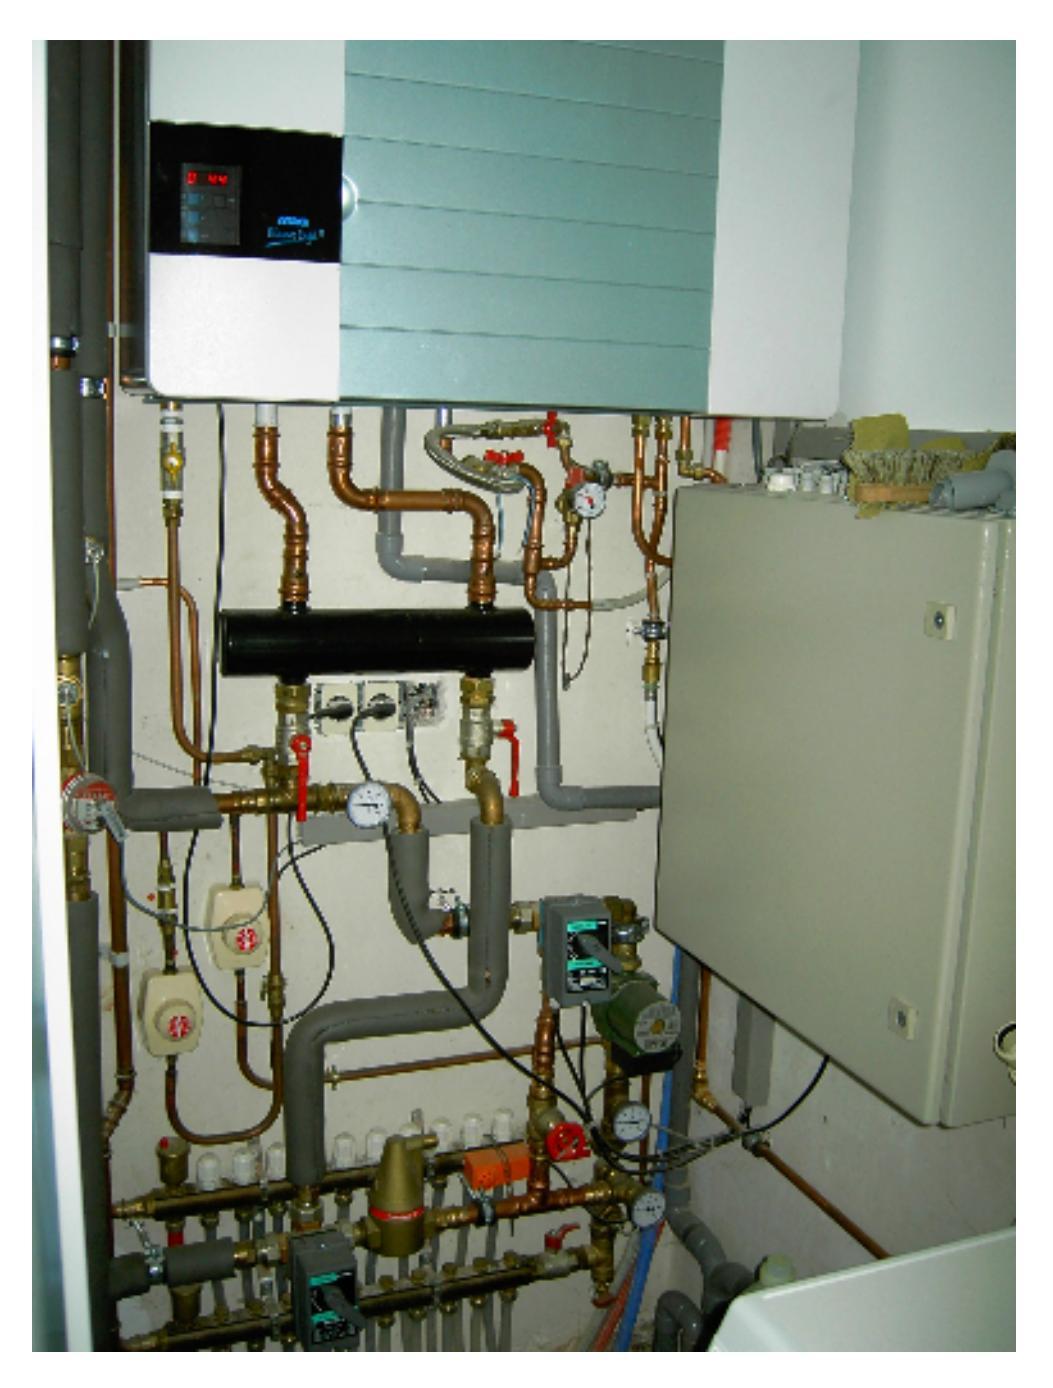
The technical installation at ground level, in a corner of the laundry room. On top you see the condensing gas boiler including inside a small sanitary hot water boiler with a topheater to avoid bacterial contamination problems when the solar boiler produces low temperatures.

The pipes and valves below it are the integration of the solar and the gas systems, with priority for solar heat when available. This is monitored and steered from the box at the right side. At the bottom (the small white hoods) the valves of the various floor heating circuits, that we can adjust manually. Every part of the house has a separate circuit. The automatic 3-way valve just at the lower border of the picture mixes solar and gas heated water. When the handle points up (as on the picture and all months of the summer period) all heat is supplied by the solar panels. The white plate in the bottom corner right is the laundry machine.
